# Protective Vents

White Paper

## CONDENSATION REDUCTION IN SECURITY CAMERAS: COMPARATIVE PERFORMANCE OF GORE® PROTECTIVE VENTS VERSUS DESICCANTS

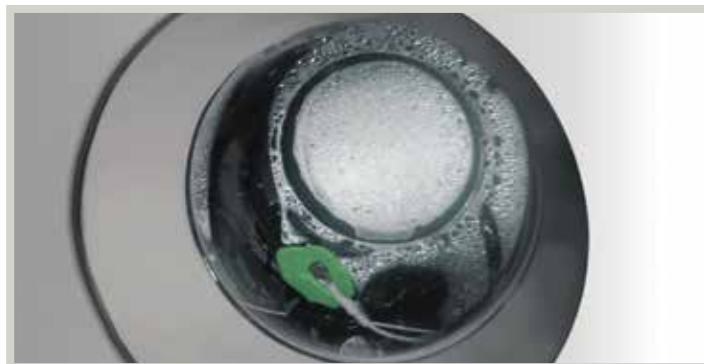
Figure 1: Desiccant could not prevent severe condensation from forming and becoming trapped within this sealed enclosure.

**2)** Subsequently, sealed camera enclosures were adopted to meet IP66 requirements. Since the sealed environment itself promoted the formation of condensation, desiccant packs were introduced before sealing the enclosure. However, desiccant packs have a limited effective life, and end-users must periodically replace them. This can be time-consuming and costly, due to the installation height of most outdoor security cameras.

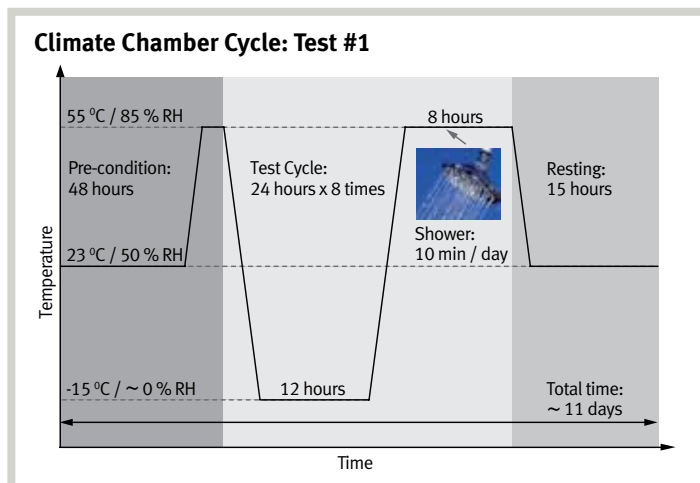
Figure 4: This climate chamber test simulated the changing weather conditions that can affect outdoor cameras.

This test employed a temperature and humidity cycle extending from -15 °C / 0 % RH to 55 °C / 85 % RH. This cycle incorporated a 10-minute water shower, to simulate rain.

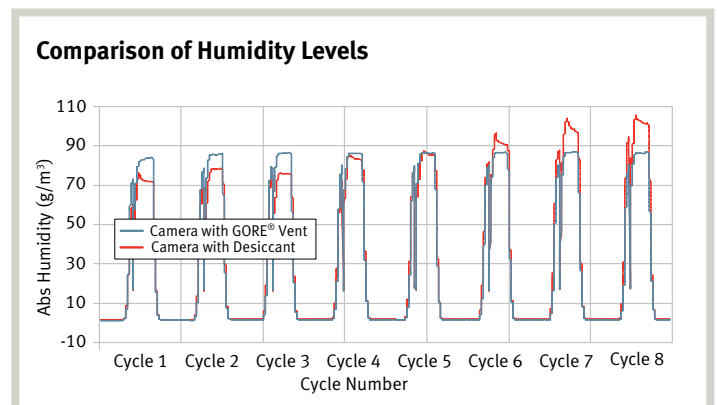
Figure 6: Beginning at Cycle 6, the fully-saturated desiccant causes a significant increase in humidity levels within the enclosure.

The recorded humidity levels within each camera enclosure also showed important differences. While humidity within both enclosures increased in response to Climate Chamber conditions, the camera with desiccant shows a significant increase, beginning at Cycle 6. This is because the desiccant moisture-absorption process reverses itself after several cycles of high humidity. At Cycle 6, the desiccant was fully saturated and began releasing water back into the camera enclosure, creating the condensation it was intended to combat.

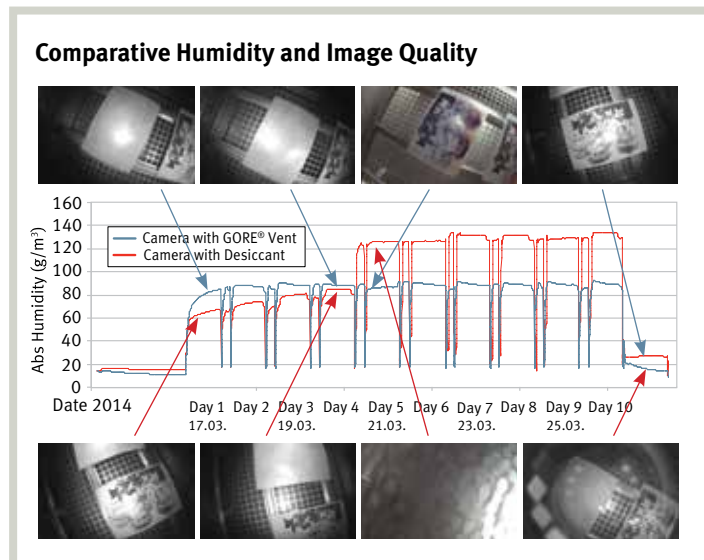
Figure 7: On Day 4, the camera with desiccant experienced a drastic increase in humidity and corresponding loss of image quality.

During the ten days, humidity levels remained consistent in the camera with the GORE® Vent. In the sealed camera with desiccant, humidity accumulated quickly over the first three days, and jumped dramatically on the fourth day. From Day 4 onward, the sealed camera with desiccant experienced serious condensation, with related degradation of image quality.

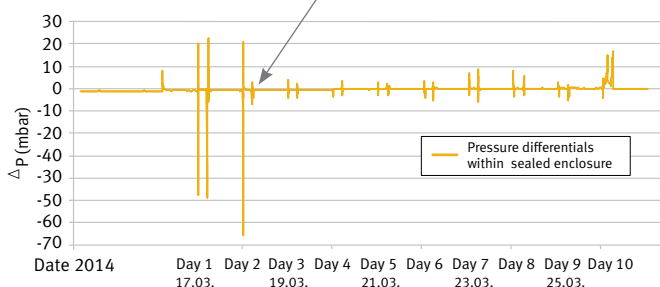
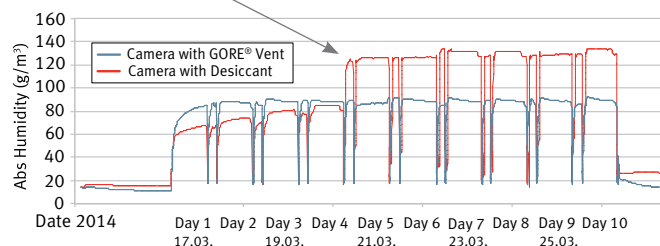
Significant and continuing pressure drop indicates premature seal failure

After seal failure, ingress of shower water caused a dramatic and sustained spike in humidity levels

Figure 8: Because the sealed enclosure could not equalize pressure differentials, the seal was stressed to failure in just two days.

As shown above, after Day 2, pressure differentials in the sealed camera diminished dramatically. Subsequent examination showed that the strong initial pressure differentials had stressed the seal to the point of failure.

The subsequent temperature drops (induced by the water shower) created negative pressure within the enclosure, drawing ambient air and shower water in through the failed seal. The desiccant could not counteract this trapped moisture. Thus, excessive condensation formed on the lens, seriously degrading the image quality.

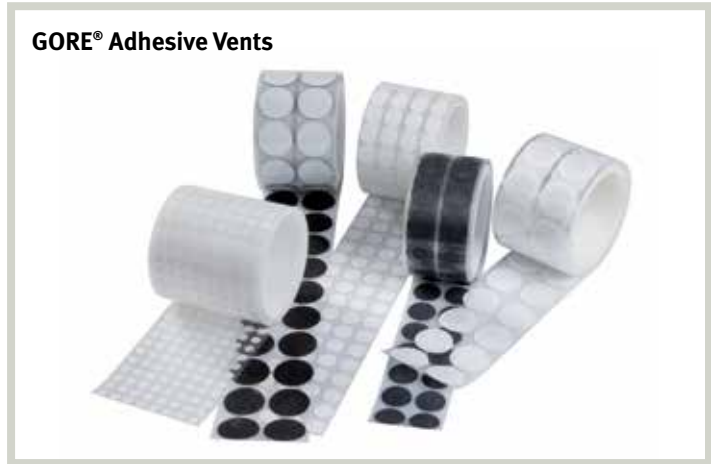
Figure 9: These flexible, low-profile vents are easily installed.
